Bender
Repair
5 Mar 24
①

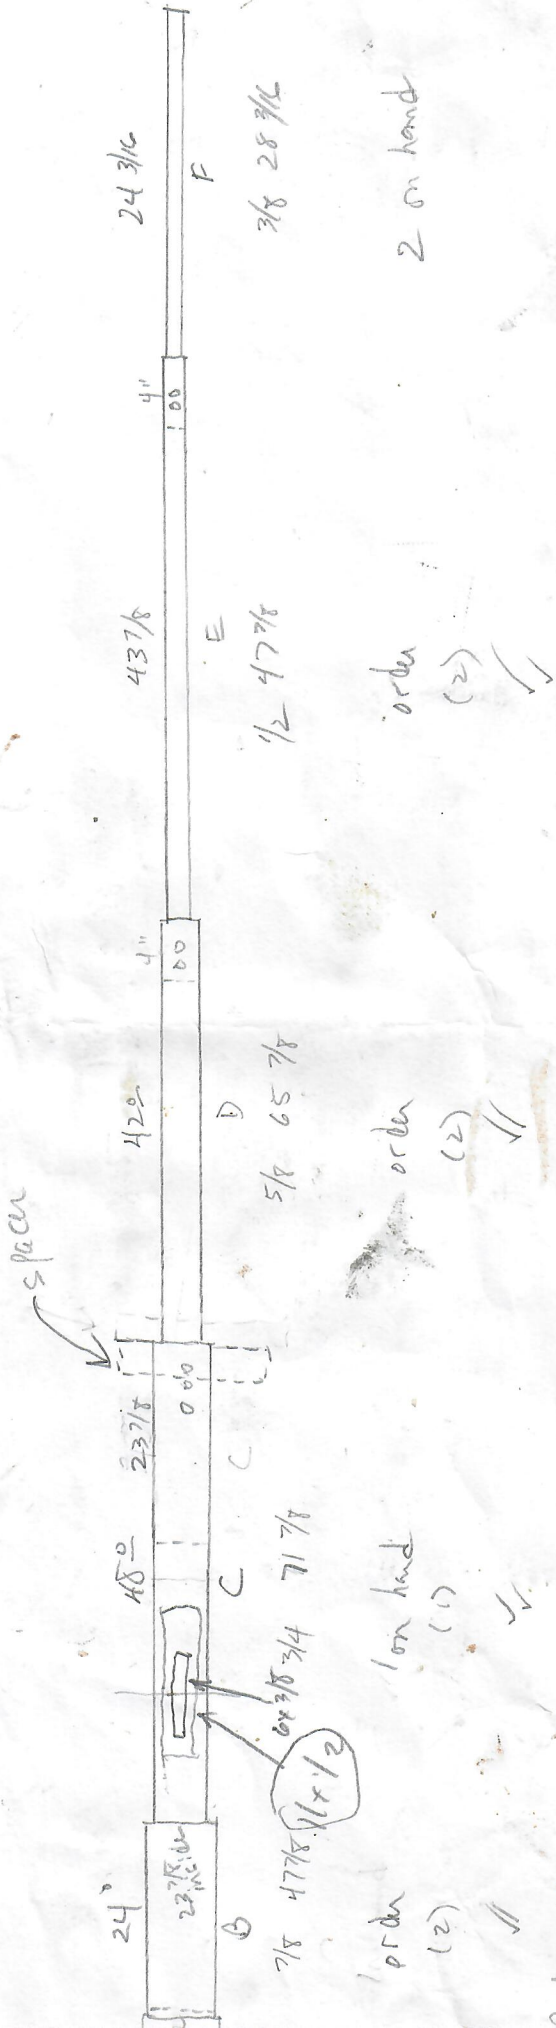
Can't get the 1/2" out of the west end of the 5/8".
 Also won't be able to get the 2 3/8" overlap of the 5/8 out of the 3/4".
 Must also assume won't be able to get the 2 3/8" overlap of the 3/4 out of the 7/8".
 Must rebuild entire element side.

1. Use on hand 1" tubing to refurbish the part next to the beam.
2. Build element, working toward the tip of lengths to match existing element.
